OSC Joni Sandoval, ER RM Art, and Property Owner (b) (6)

On 08/12/15 we performed a visual assessment of (b) (6) subdivision approximately 11 miles north of Durango. It consists of 100 acres, where 30 are utilized for agricultural, 30 are used for shared communal space, and 30 are split up for residential living. There are approximately 20 ditches, 2 lakes (Bear and Fawn Lakes), and several irrigation ditches that all feed in from the Animas River. This is a pristine community with several retirees.

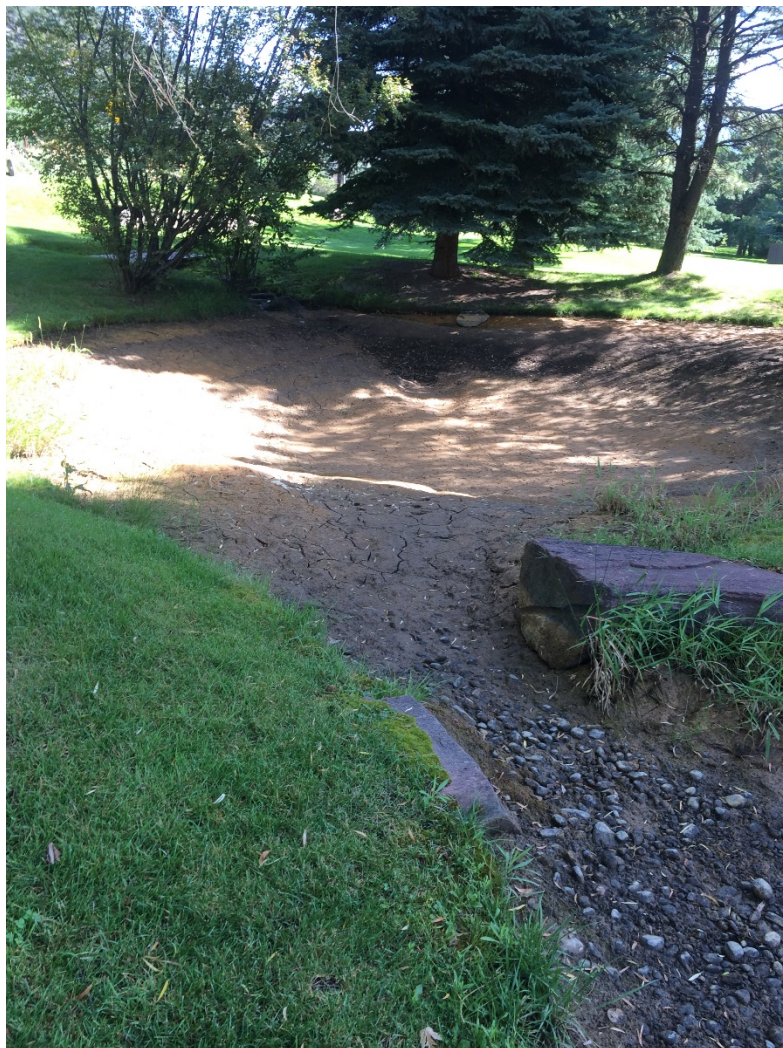
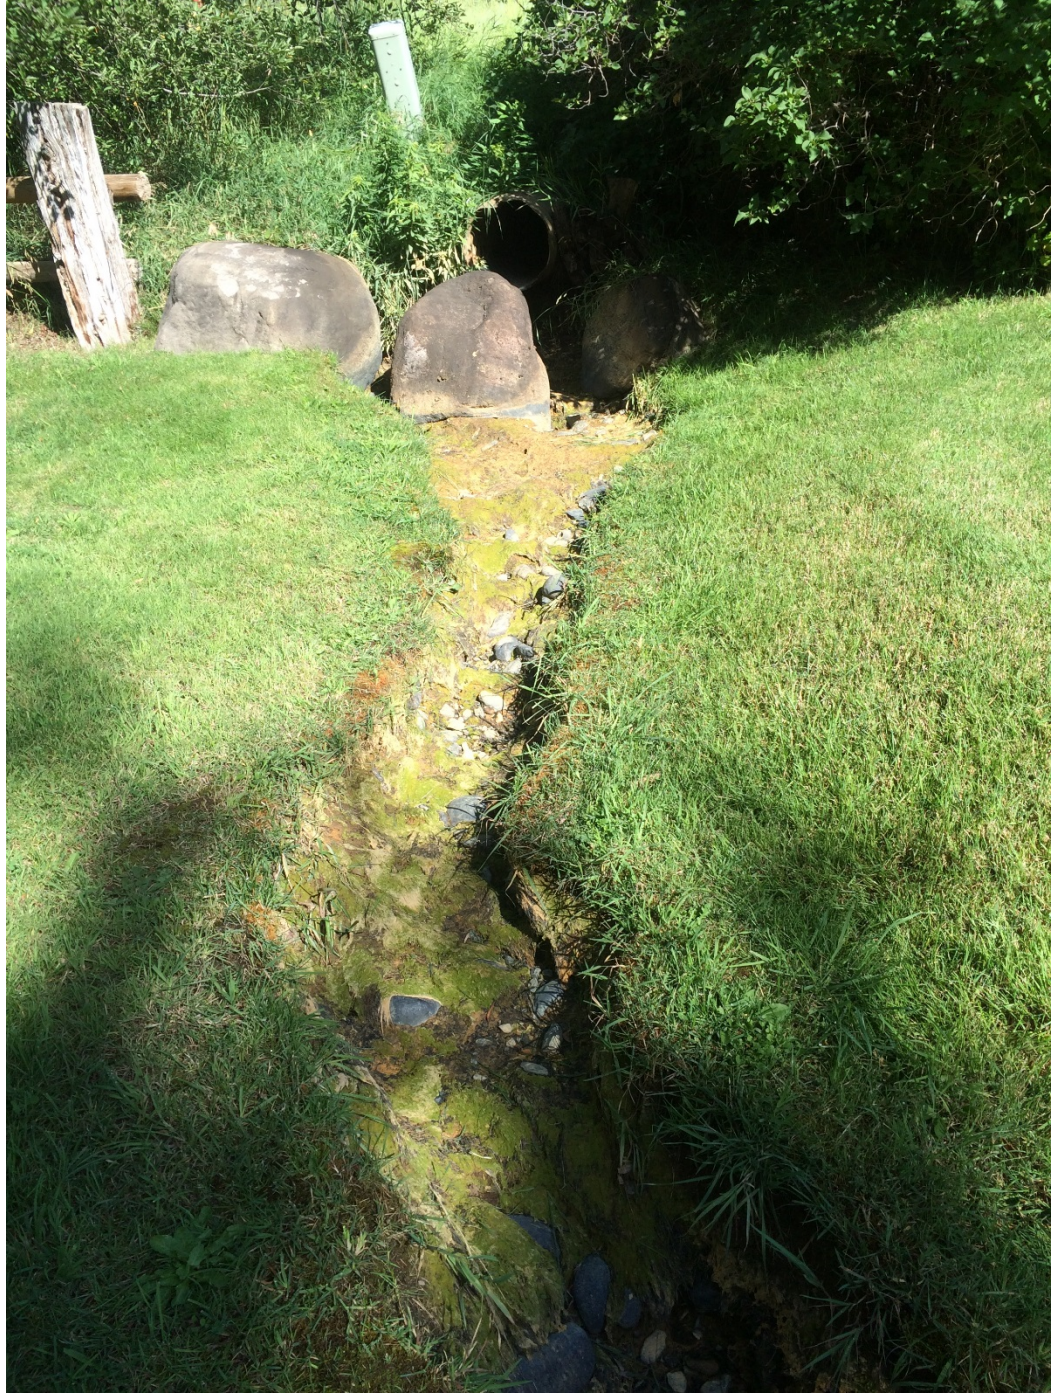
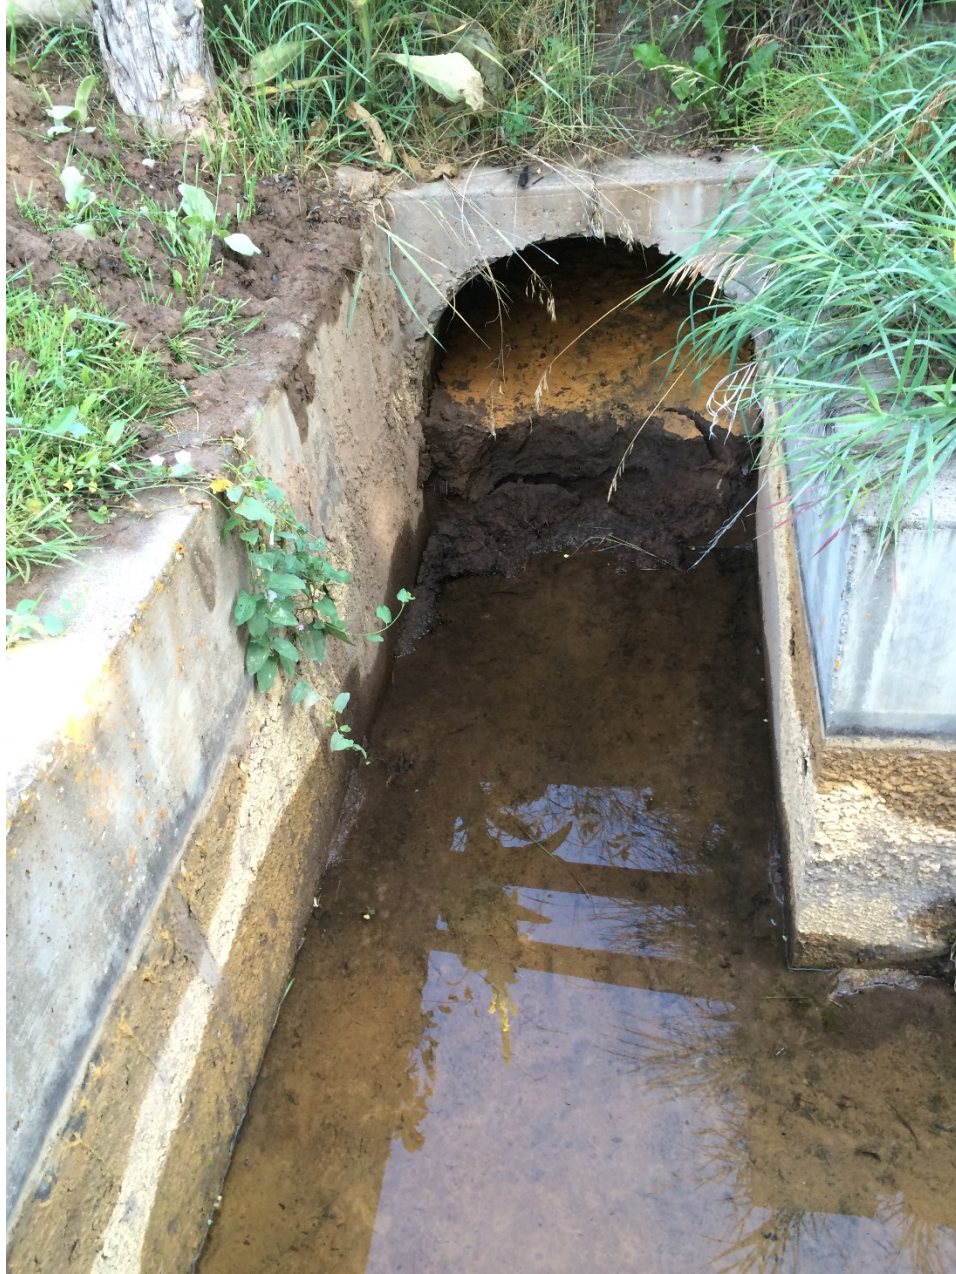
There was an empty settling pond that has orange staining left behind as well as several ditches. There was also an issue of a few dead fish in a stocked lake, which are suspected to have died, bc the CFS is too low but we haven't confirmed this yet. A CD was given to me with photos taken when the release happened, however some of the conditions have improved from the time those photos were taken. (b) (6) is contact for head gates and irrigation ditch questions.

I recommended a flush of the ditch, which would feed into all ponds and lakes. Hopefully, this will alleviate the property owner's concerns.
